US Army Corps
of Engineers
Waterways Experiment
Station

Miscellaneous Paper CERC-94-15
August 1994

Stability Study of the 1978 Jetty Rehabilitation, Yaquina Bay, Oregon, in Response to 1979-1980 Storm Season Waves

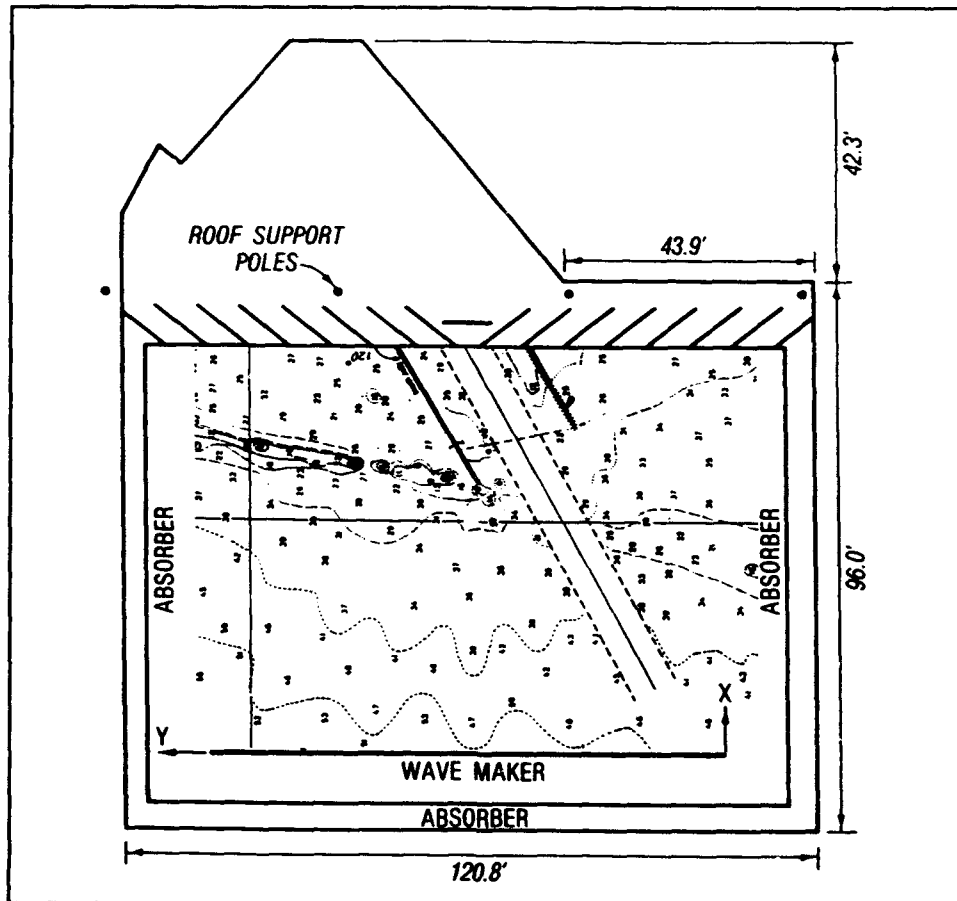
Figure 2. Plan view of physical model

The study was conducted in a 96-ft-long by 121-ft-wide (29-m-long by 37-m-wide) wave basin (Figure 2). Bathymetry was the same as that used in the earlier physical model study of the proposed 1988 rehabilitation (Grace and Dubose 1988). No additional surveys or verification of the nautical charts

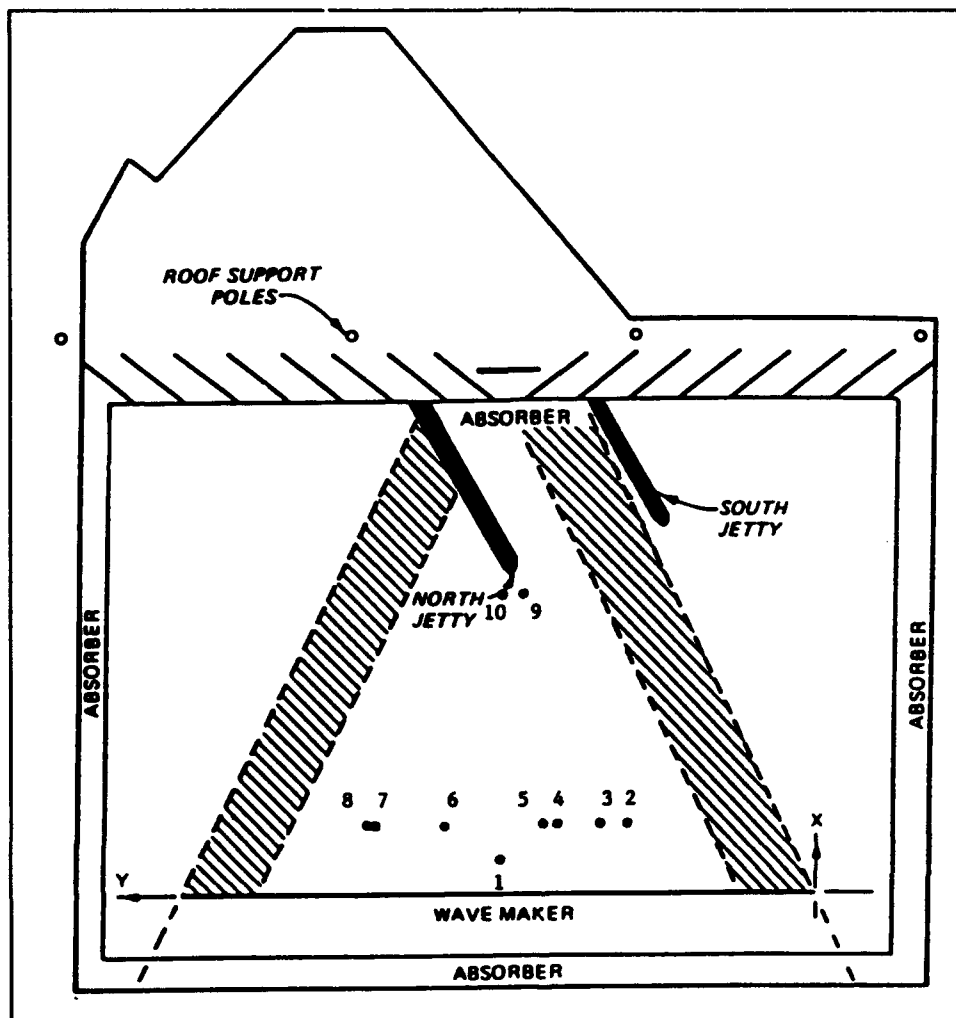
Figure 3. Wave gauge locations and wave direction limits

Wave heights were measured at 10 different locations using capacitance wave gauges (Figure 3). Gauges 1 to 8 were used in a calibration phase to ensure accurate reproduction of the target wave conditions. The last two gauges were located on either side of the north jetty head to measure wave transformation. Gauges 2 to 8 comprised a "2-3-1-7-5-1/2" linear array patterned after the larger linear array design of Oltman-Shay at the U.S. Army Engineer Waterways Experiment Station (WES) Coastal Engineering Research Center Field Research Facility (Crowson et al. 1988). The unit lag spacing of 2 ft (0.6 m) was selected to optimize the frequency and directional resolution of the array for the 42-ft (13-m) contour.

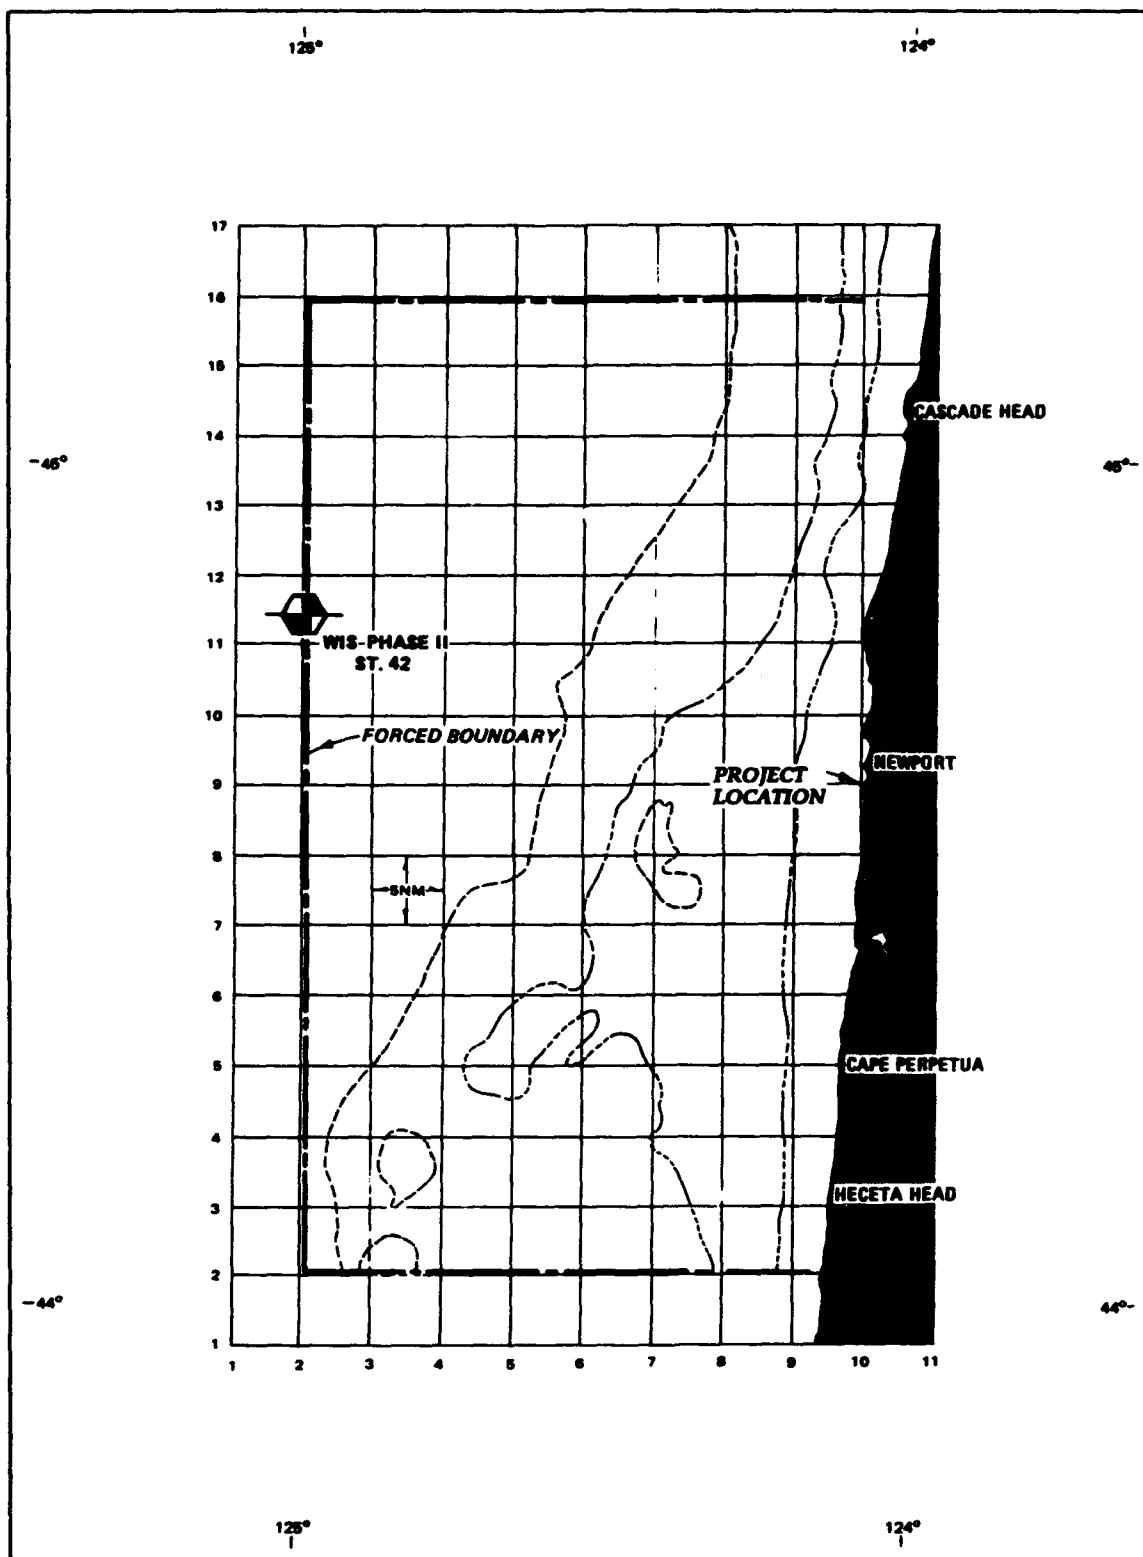
Figure 5. SHALWV model grid

Directional spectral information was saved at a depth of 16.5 m offshore of the north jetty for each storm at 12-hr intervals, approximately the same depth as the wavemaker in the physical model. The number of 12-hr segments selected for October, November, and December was 14, 14, and 18, respectively. These spectra were represented by 20 frequency bands between 0.03 and 0.22 Hz (0.01-Hz increments) and 36 direction bands between 0 and 350 deg (10-deg increments). Direction bands use a polar coordinate system with wave angle measured counterclockwise from east (i.e., 90 deg represents a wave travelling towards the north).

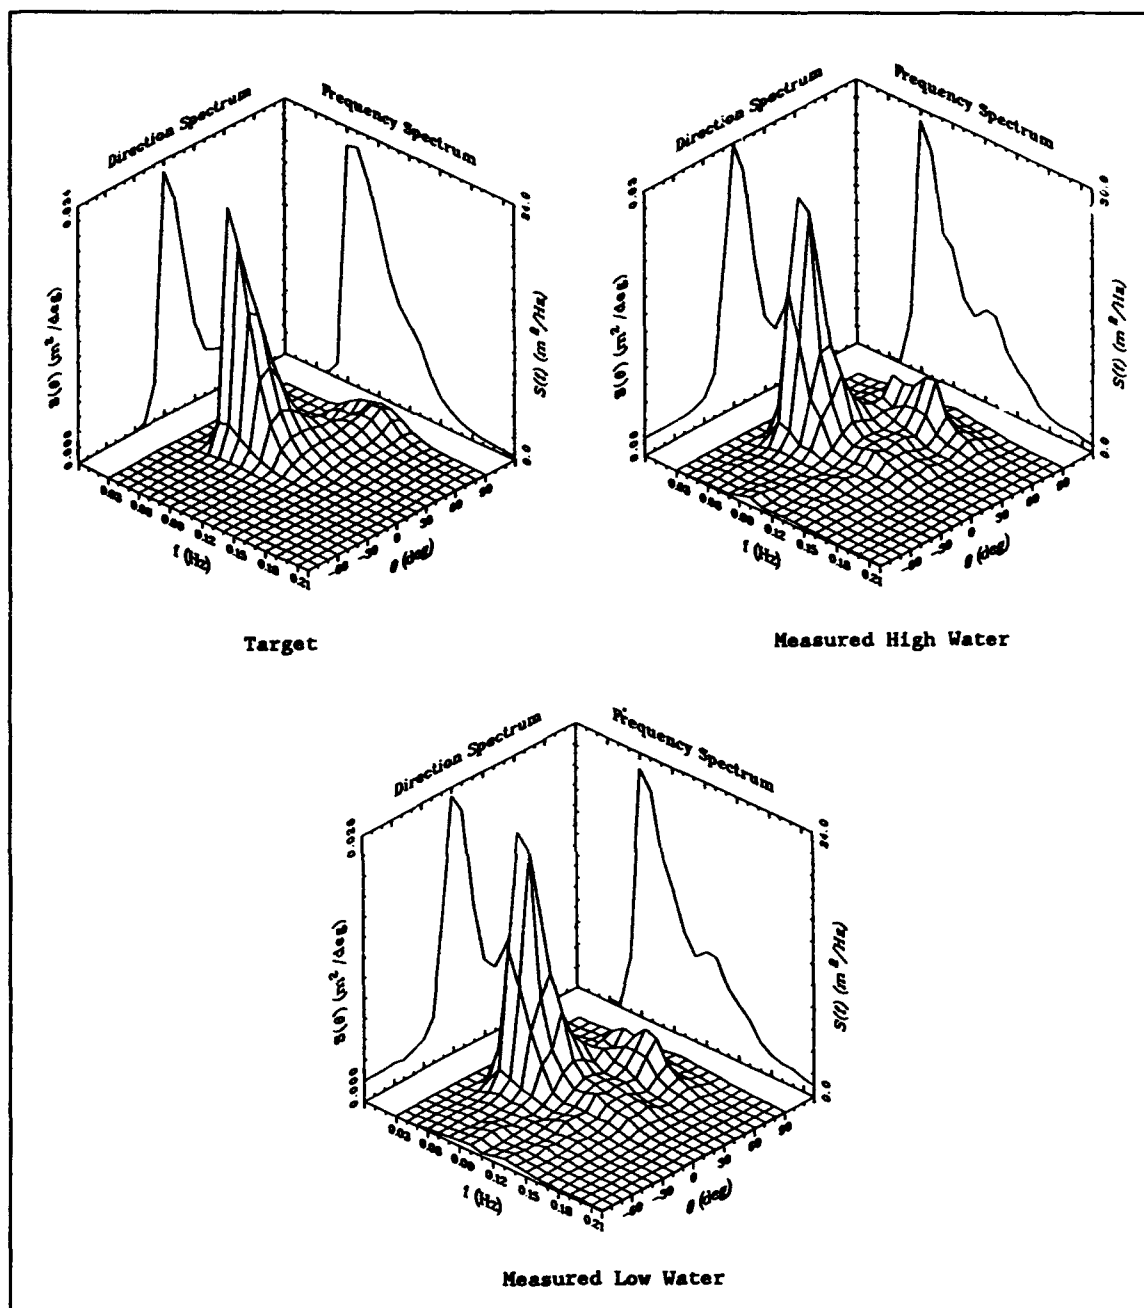
Figure 6. Target and measured model directional spectra for case YD25M

Figure 6 illustrates target and measured model (scaled to prototype) directional spectra for high- and low-water levels for test case YD25M (i.e. December 25, midnight). Target and measured directional spectra for the other cases are contained in Appendix C. The entire linear array (gauges 2-8) was used in the directional spectral calculations. The 3-D directional spectra have units of $m^2/Hz/deg$. The rear vertical panels on each figure illustrate the integrated direction spectrum and frequency spectrum. The frequency spectrum is obtained by summing the directional spectrum over all directions for each

frequency and multiplying by the direction increment 10 deg. Similarly, the direction spectrum is the sum over all frequencies for constant direction, multiplied by the frequency increment 0.01 Hz. In general, the agreement is very good to excellent. In some cases, the target directional spectra had energy traveling in a northerly direction (i.e., 90 deg) which was not measurable with the linear array. Visual observation of the waves as they left the DSWG did verify, at least qualitatively, that this energy was being accurately simulated.

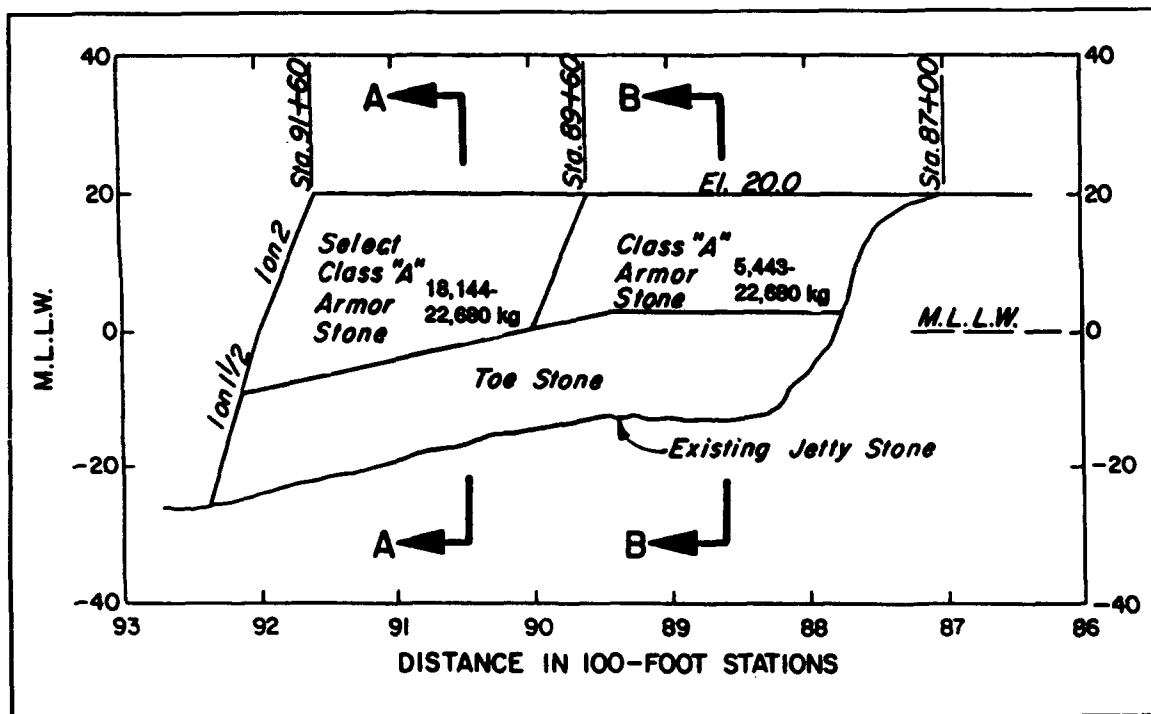
Figure 9. Jetty profile

The jetty profile and cross sections are presented in Figures 9, 10, and 11. The rehabilitation plan was characterized by a crest elevation of +20 ft (6 m) mllw and a crest width of 30 ft (9 m). Armor sections were typically composed of two layers of 6- to 25-ton (5,443- to 22,680-kg) stone (average weight = 10 tons (9,072 kg)). The model structure is shown in Photos 1 and 2.

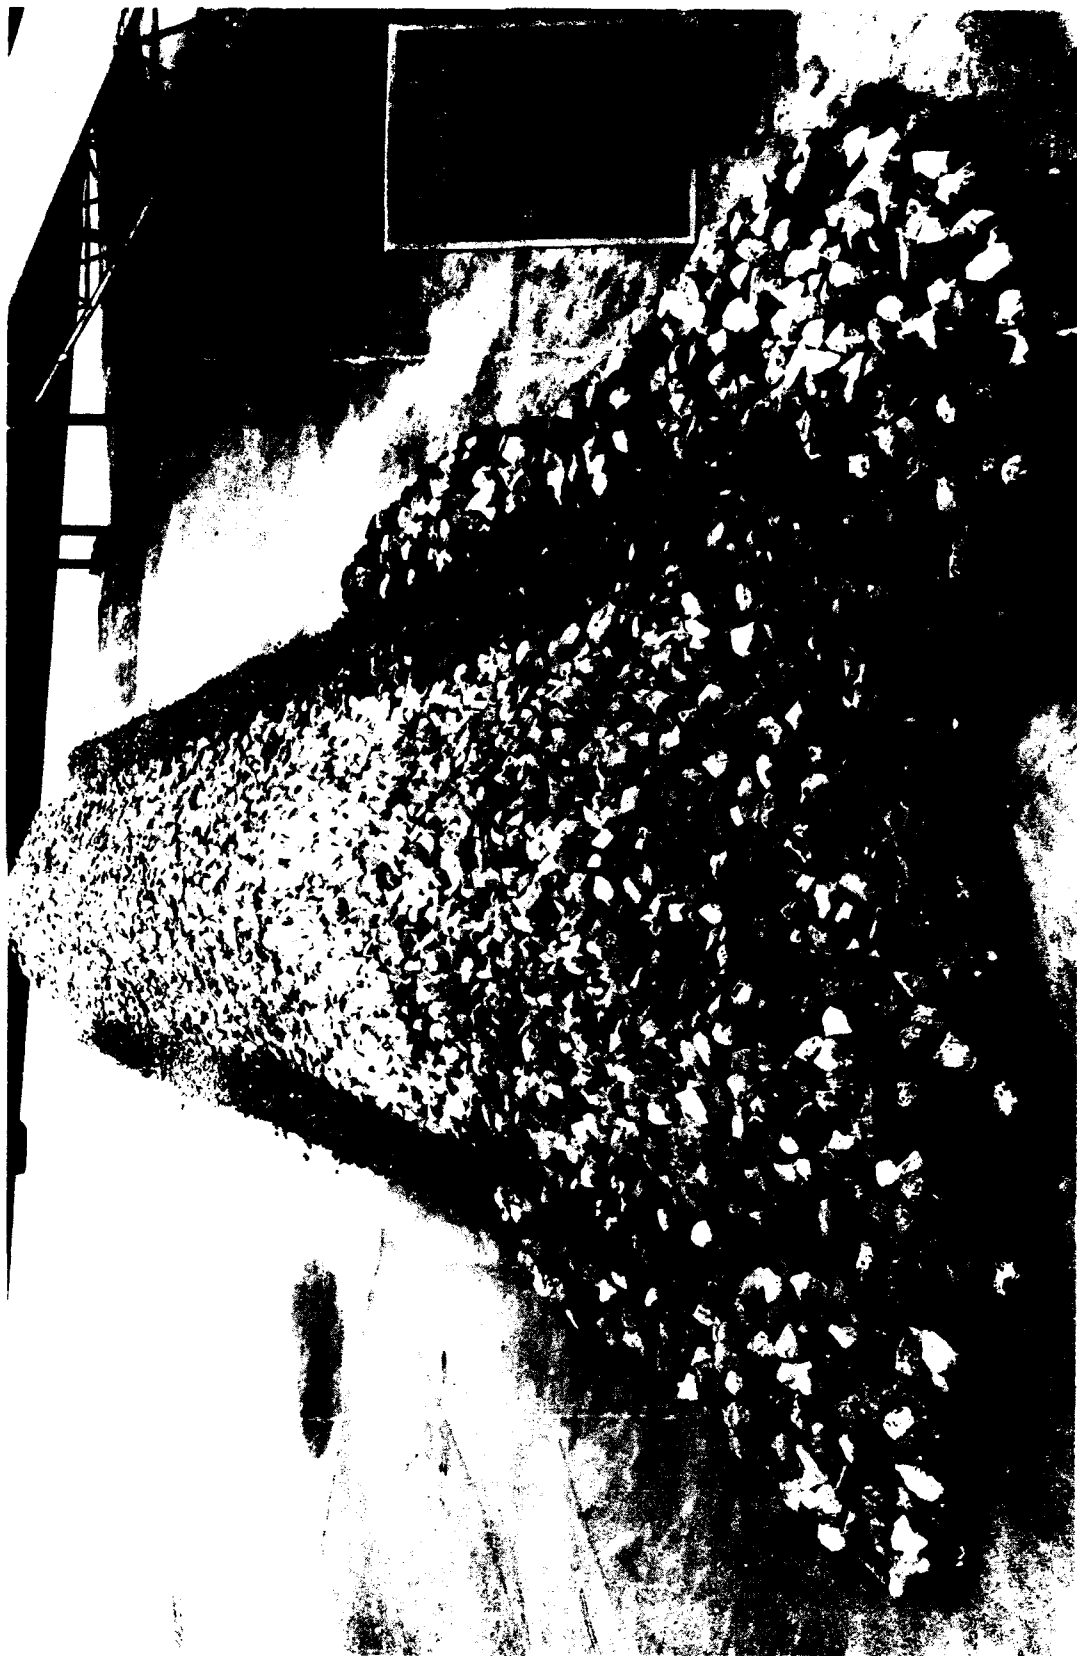
Photo 1. Long-axis view of structure before testing

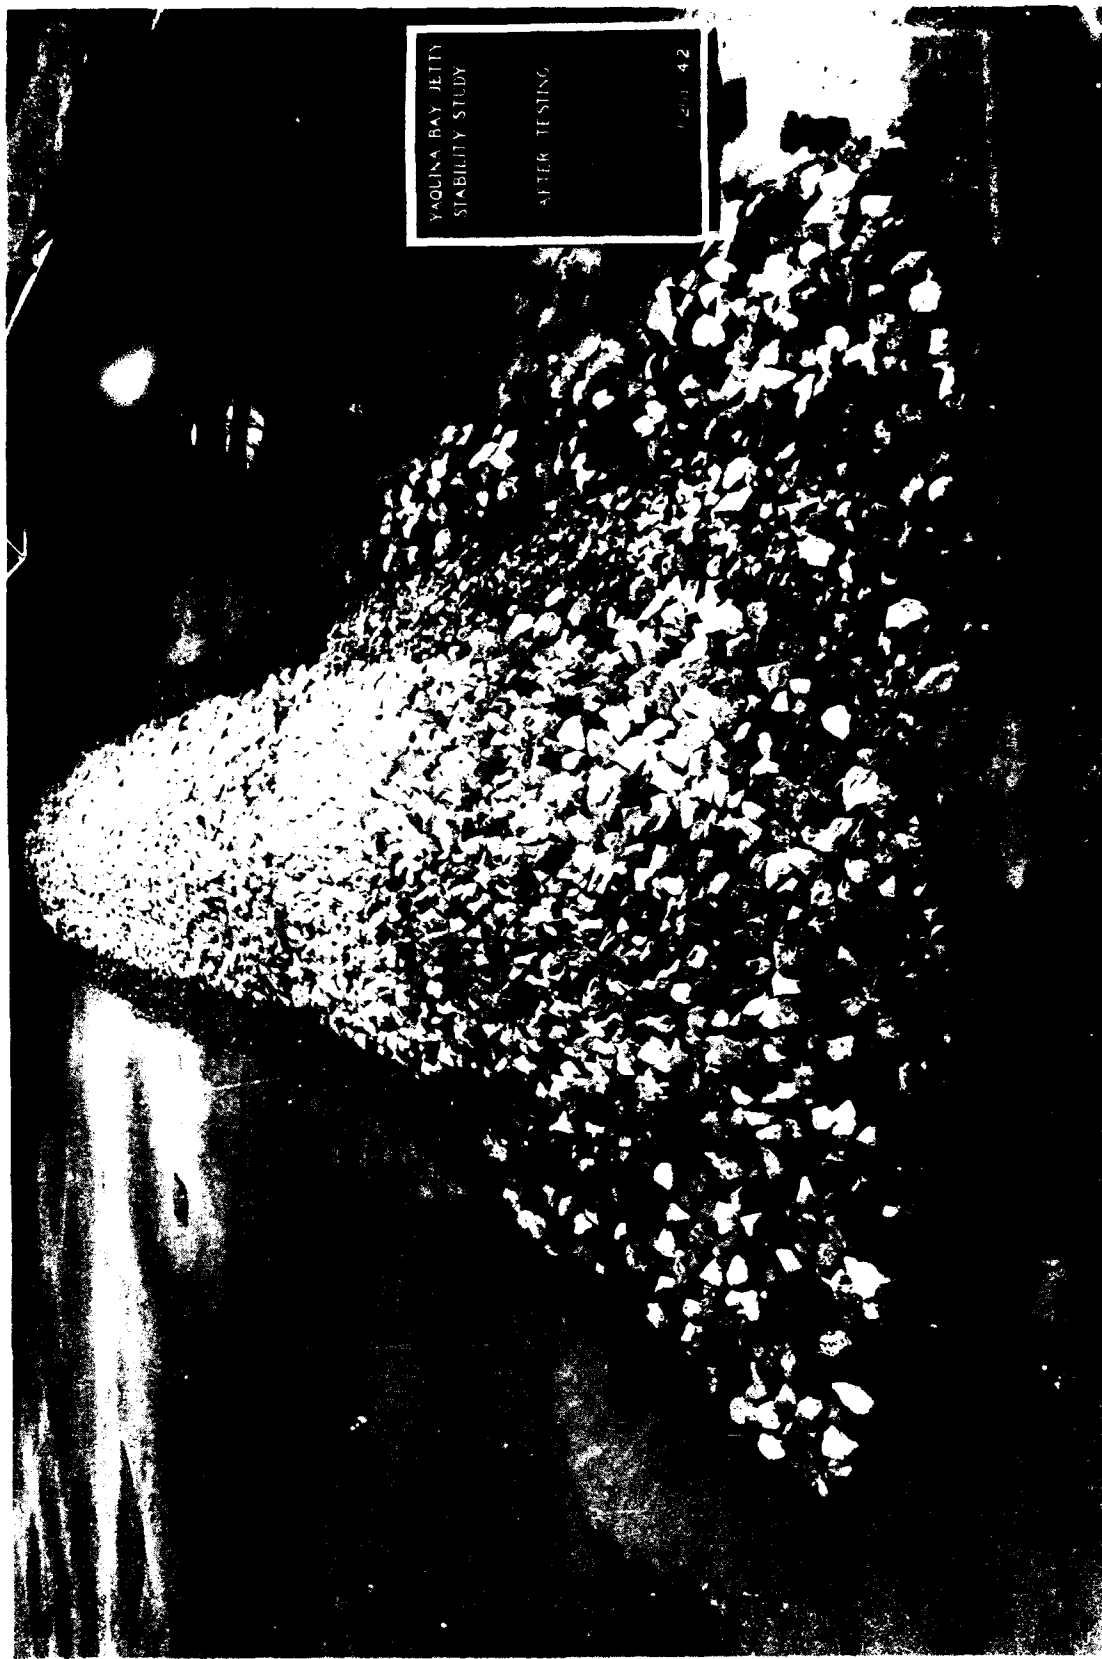
Photo 3. Long-axis view of structure following initial stability test

Initiation of the December storm (step 21) caused displacement of one armor stone and rocking of a few others. General loosening of the armor above the swl was observed during steps 22, 23, and 24. Steps 25 and 26 produced minor rocking of 3 or 4 armor stones. The structure emerged from the 26-step test series in good condition. Loosening of the armor observed in steps 22, 23, and 24 abated during steps 25 and 26 and appeared to have no significant impact on overall stability (Photo 3).

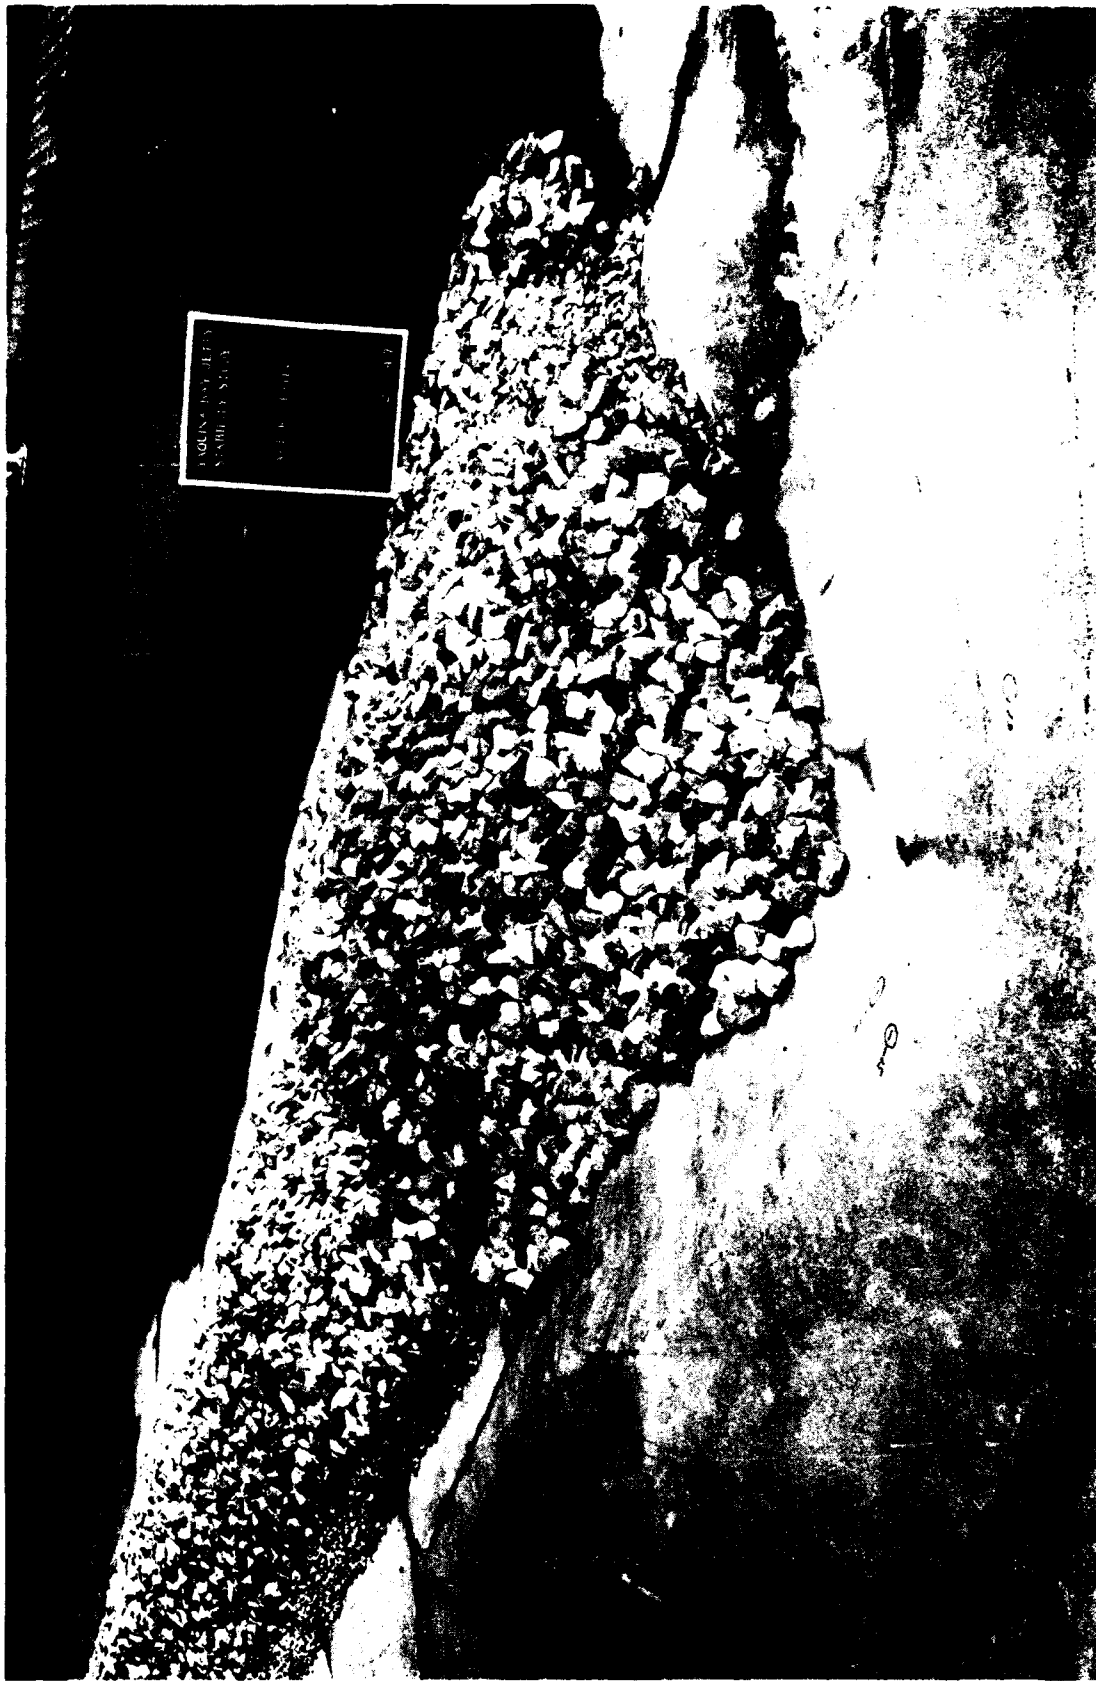
Photo 5. Sea-side view of structure following repeat stability test

Finally, the model structure was rebuilt to initiate "hot spots" by dislodging and loosening some stones, and retested. Since most of the observed movement during the first test series occurred during the December storm, it was decided to use only the six December storm conditions for this last test series. Test results from this repeat series are summarized in Table 6. Step 1 caused significant loosening of the armor with nine stones being displaced. At the conclusion of step 1 it was anticipated that the repeat test might show a significant increase in damage above that observed for the original test. However, steps 2, 3, and 4 produced only rocking of five or six armor units, with no additional displacement observed. Minor rocking of two or three armor units was observed during steps 5 and 6, with the structure emerging from the six-step simulation in good condition (Photos 4 and 5).
